BELZONA SEAL-A-TANK SUCCESS IN SERVICE FOR OVER 13 YEARS

Refinery, West France

Tanks at a refinery in West France were suffering from water ingress.

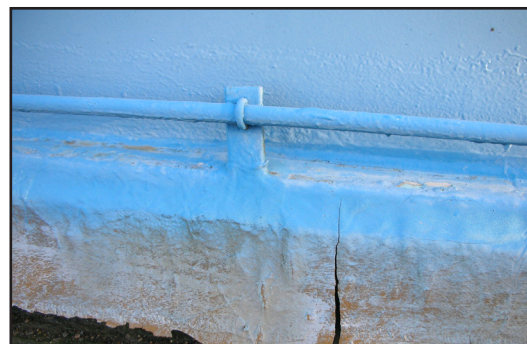
The refinery had an existing tank base sealing system in place which was failing due to its rigidity. The failed system had resulted in water ingress, causing corrosion at the base of the tank and required protection for the long term.

1. Failing system that needed replacing.
2. Surface conditioned.
3. Testing the annular rim through Belzona 3111.
4. Seal-a-Tank system still in an excellent condition.

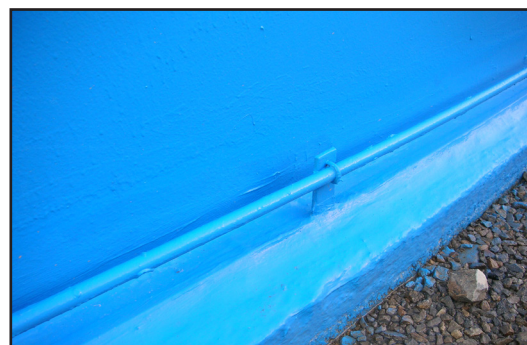
4.

This application was inspected three years after and found to be in good condition with no signs of corrosion. Subsequently, it was reinspected in 2017 and still found to be in excellent condition. The customer was very pleased with the application and its longevity in service. In addition, the customer was pleased because, unlike competitor systems, it is possible to inspect the thickness of the annular rim through Belzona 3111.
