BELZONA SUPERWRAP ALLOWS DRILLING TO CONTINUE

A platform off the coast of Baku had to stop drilling due to wall loss on the HP mud lines. The problem areas were on 3 bend sections.

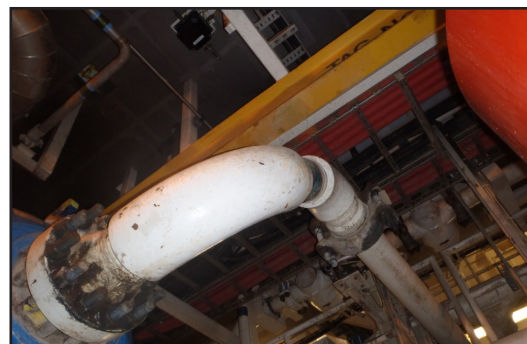
1. View of Pipe before 21 wraps.
2. View of Pipe before 12 wraps.
3. View of SuperWrap repair: 21 wraps.
4. View of SuperWrap repair: 12 wraps.
