## BELZONA REPAIRS MANWAY FLANGE ON RAILWAY TANK

Petrochemical Company, Slovakia

Railway tank used to transport raw materials to and from the petrochemical plant.

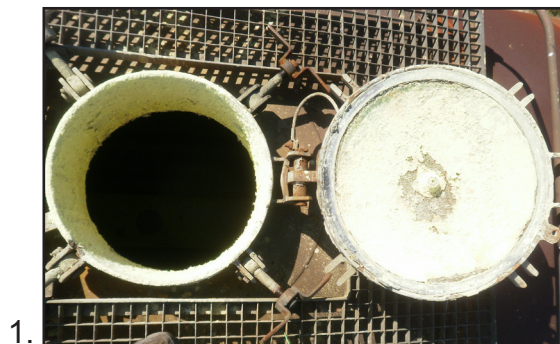
This tank was used to carry sulphuric acid, however, the manway area was not suitably protected so suffered from corrosion damage.

1. Damaged manway.
2. Following grit blasting.
3. Completed application.
4. Alternate view.
