## BELZONA REPAIRS FLANGE RING ON HCL TANK

District Heating Plant, Slovakia

Tank for storing 34% HCL.

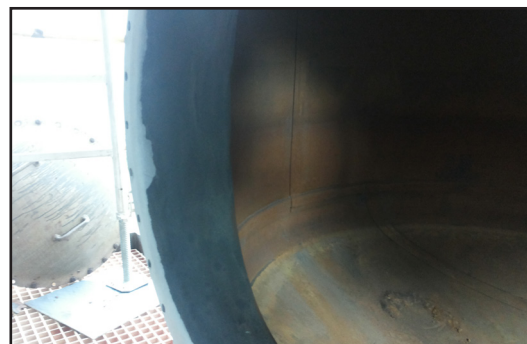
After a long lay-off period the area near the flange had suffered from corrosion and mechanical damage. The rubber coating inside was good, but problem was close to gathering ring.

1. Damaged flange.
2. After blasting.
3. First coat of Belzona 4311.
4. Completed Belzona application.
