BRISBANE CITY CENTER STEPS MADE SAFE BY BELZONA

Brisbane City Centre, Australia

2017

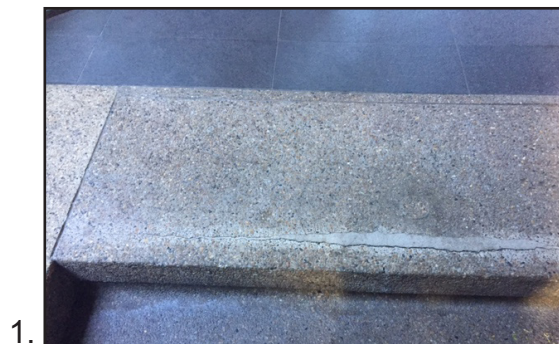
An overhanging step in the centre of Brisbane had become worn and caused broken and loose concrete to cause a trip hazard.

1. Broken step.
2. Loose concrete removed.
3. Former installed.
4. Completed repair back in service.
