## BELZONA EXTENDS THE LIFE OF MIXING BLADES

Plaster Production Factory, Slovakia

2016

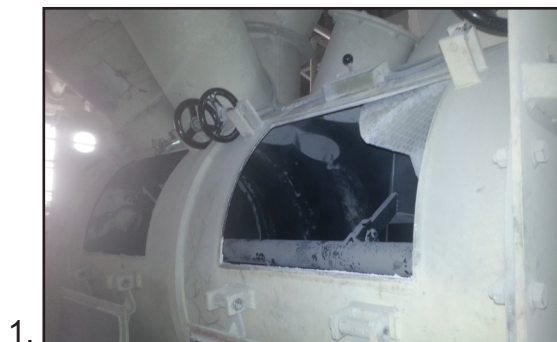
Customer used special anchors for mixing in plaster production.

1. Mixing machine.
2. Belzona 1812 and 9811 application.
3. Anchor after 12 months mixing.

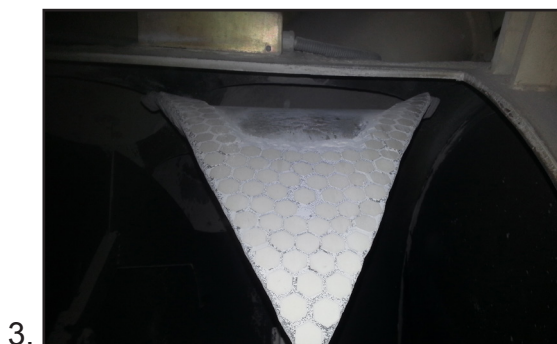
Conventional welding of hard steel wear plates was very complicated. After a 6 month trial with Belzona protection there was no damage, after this the customer ordered all future anchors to use the Belzona protection system.
