BELZONA REPAIRS ALLOW OFFLOADING TO RESUME

FPSO, Gabon

Low pressure steam turbine

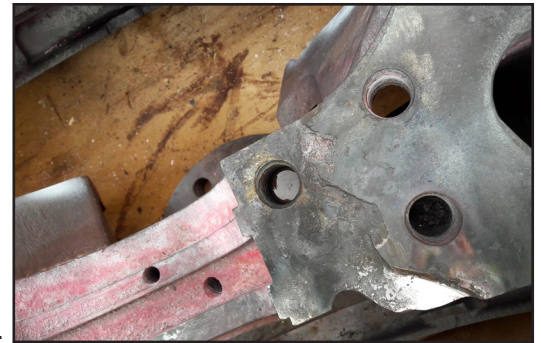
Corrosion and significant loss of metal on many areas of one half of the flange face.

1. Localised damage on the flange face.
2. After surface preparation
3. Forming in-operation using the other half of the split casing.
4. Finished result.
