BELZONA® PROTECTS SHIPS RUDDER FROM CAVITATION

Guangzhou.

October 2013

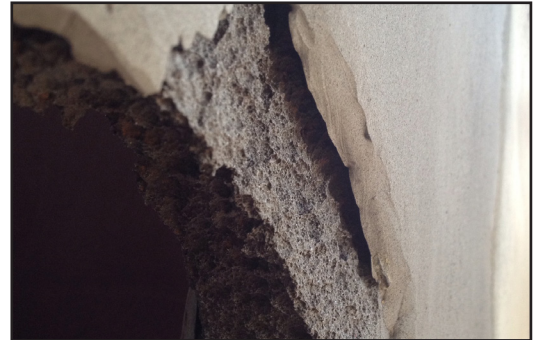
1.

Due to the nature of the shape of a rudder, coupled with disturbed water flowing from the propellor, cavitation damage was aparent on the rudder. Previous attempts to resolve the situation involved overlaying with stainless steel. This led to galvanic corrosion in places and did not stop the cavitation.

- 1 - Overlaid stainless steel corroding and cavitating
- 2 - Damaged area rebuilt and coated
- 3 - Full coating system applied
- 4 - Final View

Following surface preparation, All pitting was filled and rebuilt with Belzona 1311. Belzona 1341 was then applied as a 1 coat system straight over the Belzona 1311. Once the Belzona 1341 had cured, Belzona 2941 was applied to the areas where Belzona 2141 would be applied. Belzona 2141 was then applied in a 2 coat system with the top coat as black.
