BELZONA REPAIRS 100 YR OLD WATER DAM

100 yr old concrete hydro dam

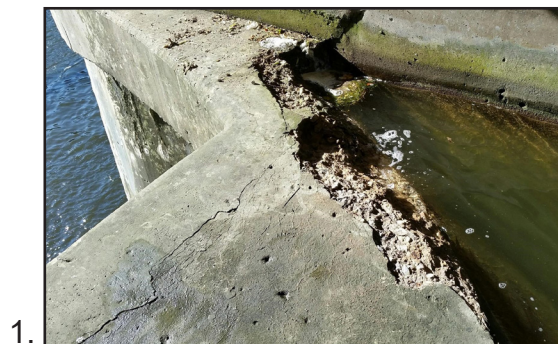
The face of the concrete hydro dam was damaged at the waterline due to ice and wave. The damaged area is partially submerged and the entire area frequently wet from wave action. The dam has been declared a historic site so repair materials need to closely match the appearance of the original material.

1. Damaged area at waterline
2. Work in process.
3. Finished repair
