## BELZONA PRESERVES CONCRETE PILES OFFSHORE

Gulf of Mexico, USA

November 2016

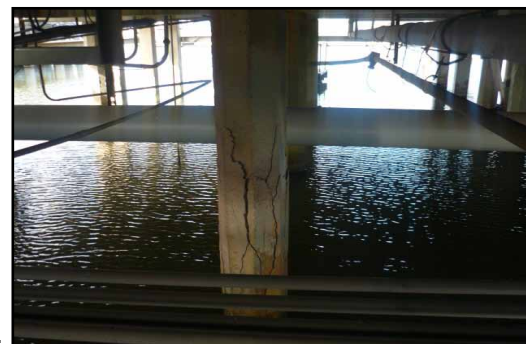
1.

Offshore application. Marshland soil settlement is causing concrete piles to show stress fractures. Exposed rebar is corroding.

At an aging facility off the Louisiana coast, a gas lift station is experiencing fractures in their concrete piles under the foundation. Uneven stress causes some piles to bear more load as weight is transferred off other piles.

### PICTURES
