BELZONA REPAIRS AND PROTECTS LEAKING TRANSFORMER TURRETS

National Grid, Scotland, UK

October 2015

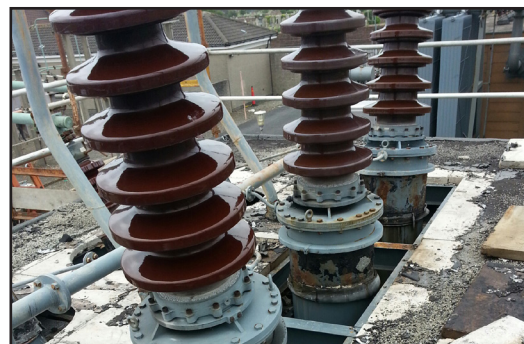
Transformer turrets are normally sealed from the weather into the roof above the transformer. Rainwater had leaked in between the roof & the turret allowing corrosion to take place.

1. Turrets before work commenced
2. Close up of the corrosion on the turrets
3. Plates bonded in place with Belzona 1161
4. Belzona 5831 applied to provide long term corrosion protection
