BELZONA 1212 KEEPS RO WATER FLOWING

Thermal power plant, Warora, India

Pumping system in Reverse Osmosis (RO) water plant at a 2X300 MW Coal based power plant.

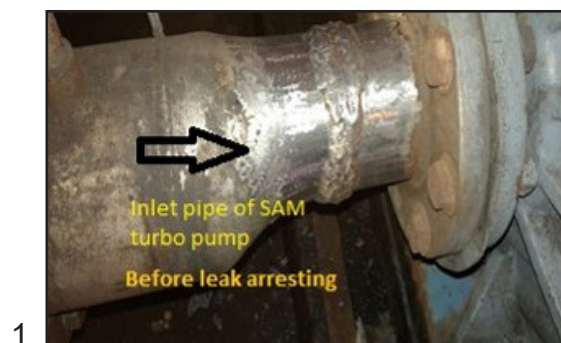
Water leakage at 5-6 kg/cm² at 7 numbers of circumferential joints from inlet pipe of SAM turbo pump.

1. SAM Turbo Pump before repair
2. Wetting the surface with Belzona 1212
3. Finished repair
