## BELZONA PROVIDES SOLUTION FOR LONG TIME LEAK

20 feet of basement wall was leaking where it meets with the floor.

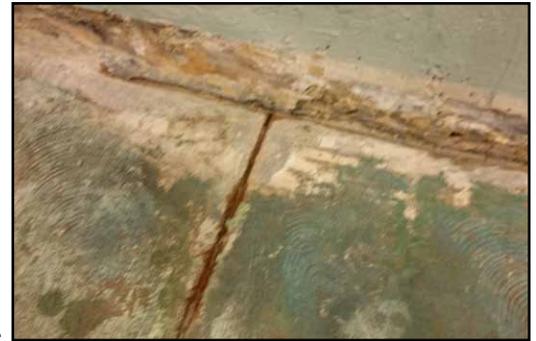
Water was leaking into work spaces where the wall meets with the floor. The combination of an ongoing leak and a subterranean work space was creating an unhealthy work environment. The opposite side of the wall was under approximately 30 ft of earth and concrete so they needed a way to repair it from the negative side.

1. Area to be repaired, the joint where the leak mostly occurred
2. Same area with Belzona 2221 in place
3. Application in process
4. Application complete

Application was carried out using a modified version of Belzona System Leaflet RPA-8. Belzona 2221 was selected as an alternative to a Belzona 3000 series product due to the fact that there was potential for a build up in head pressure behind the leak. Work was delayed until there was a dry spell and the application area was free of moisture. Application area was prepped using a concrete grinding disc and loose dust and debris was cleaned up. The area was then conditioned with Belzona 2911 and edges were taped to contain the repair to the conditioned area. Belzona 2221 was applied as a flashing that would stop moisture while simultaneously allowing for movement of the wall and floor.
