HISTORICAL STEEL STAIRCASE RENEWED WITH BELZONA

The original steel staircase on a historical building in downtown Kansas City was brought back to life with Belzona.

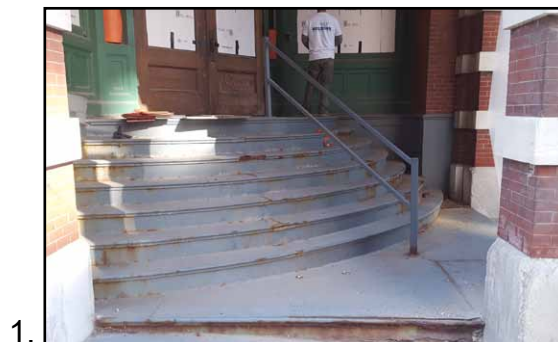
The original 1940's steel staircase at the future home of the Kansas City Museum was in much need of repair or replacement.

1. Before/previous condition
2. After media blasting
3. After rebuilding the step nosings with Belzona 1221
4. Finished with anti-slip aggregate installed
