BELZONA POSITIVE GRIP SYSTEM PROVIDES SAFETY TO WORKERS

A manufacturer's movable step ladders needed a permanent non-slip added to keep workers safe.

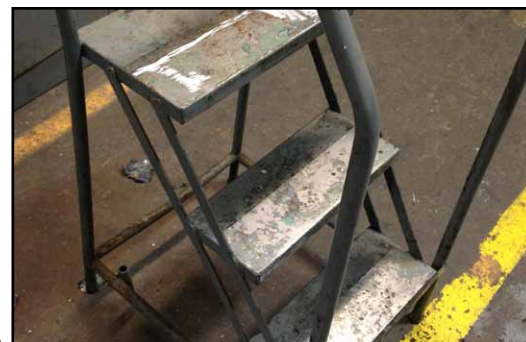
Steel steps used around manufacturing equipment in an oily environment were slippery and hazardous to workers safety. Previous applications of non-slip tape were short lived and not effective.

1. Steps prepared for application
2. Application of Belzona 5811 in progress
3. Application of Belzona 5811 and 9211 completed
4. Application revisited two months later, already outperforming the non-slip tape

Application was carried out using Belzona Know-How System Leaflet FPA-8. Steps were cleaned and roughened with an angle grinder. Edges were taped off to create clean lines. First, Belzona 5811 was applied at 20 mils thickness, then Belzona 9211 was added to the point of rejection.

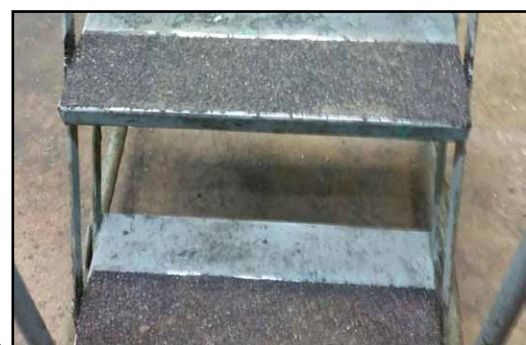
4.

One of the alternative solutions was to use a non-slip tape which had already been proven to be ineffective. When the application is completed on remaining steps the cost of the Belzona application will be approximately double per square foot but will last approximately forty times longer, paying for itself in the first two years and saving the customer far more over time.
