WATER RUNOFF PIT WALLS REPAIRED WITH BELZONA

Kansas City, MO

November, 2016

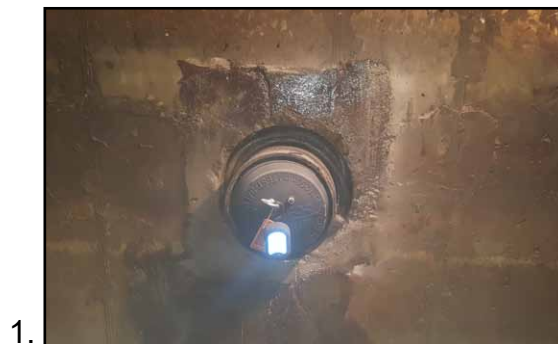
1. Surface preparation
2. Belzona 4131 used to bring back original conditions to wall
3. Belzona 5811 used to seal over repairs
4. Ball Valve Plug used to stop water flow for application

The application was carried out in accordance with Belzona System Leaflet WPA-4. The area around the pipe was hand prepared with a grinder to achieve the desired surface profile. Backing rod was pushed into the voids around the pipe to create a backing for Belzona 4131. Finally, Belzona 5811 was applied to seal the repair area.
