BELZONA CURES DAMP WALLS

Private Residence, North Yorkshire, UK

2016

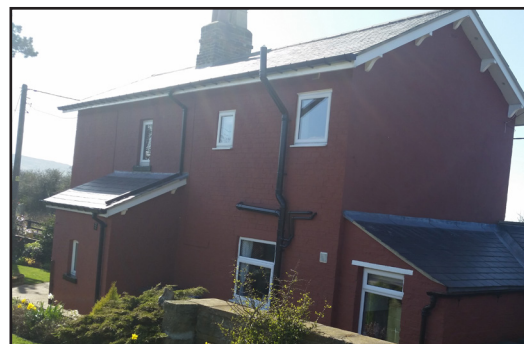
Recurring damp was causing damage to the interior and subsequent remedial works. Several solutions had been tried in the past but they had failed to solve the problem. The cause of the damp was not obvious and after seeking professional advice from several sources, the customer was advised that driving rain was the most likely cause.

1. House before application
2. Damage to interior
3. Ineffective existing coating
4. Completed application

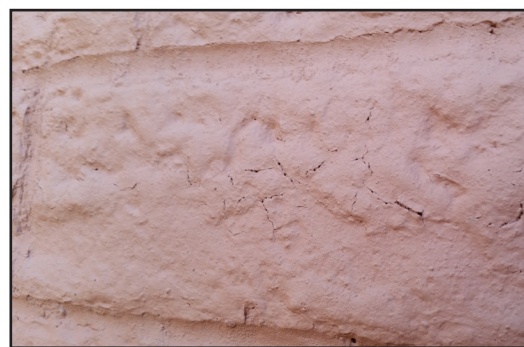
3.

It was found that the previous coating had numerous defects that allowed water to become trapped, causing the damp. The flexibility and microporous properties of Belzona 5151 allow moisture to escape while preventing further ingress. Since applying the Belzona 5151 the client has not had any problems.
