BELZONA REPAIRS GTG SYNTHETIC LUBE OIL TANKS

FPSO, Offshore Ghana

Lube Oil Tanks onboard an FPSO located offshore.

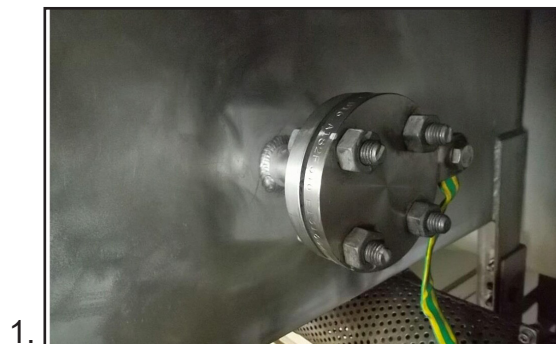
A crack was found on a Stainless Steel LO tank on one of the gas turbine generator sets. The crack ran approximately 5-10cm around a 1" nozzle.

1. Surface preparation
2. Belzona 1511 being applied to doubler plates
3. Belzona 1391T being Injected in-between doubler plates and tank
4. Doubler plates bonded onto tank

Application was carried out in accordance with Belzona Know-How System Leaflet TCC-1 and following a client approved Method Statement. A doubler plate was fabricated and sealed in place with Belzona 1511 before Belzona 1391T was injected to cold bond and seal the doubler plate to the tank. This sealed the leak and added extra strength to the tank.
