BELZONA RESTORES CENTURY OLD SHIP

HMS Caroline, a ship owned by the National Museum of the Royal Navy, was undergoing a hull refurbishment in dry dock at Harland and Wolff in Belfast.

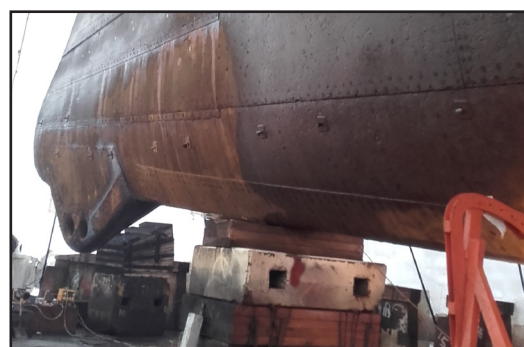
Numerous compartments, fuel tanks and storage areas below the waterline had been taking on water. Welding was limited to areas of the hull that had no leaks, and that were robust enough to withstand hot works. The client was looking for a long-term repair solution, capable of bonding to a poor substrate and with rapid cure times as the dry dock was already booked for another ship repair.

1. HMS Caroline in dry dock
2. Hull in need of leak sealing
3. Cold-applied, fast-curing solution administered
4. Hull after repairs and coating

The application was carried out in accordance with Belzona System Leaflet SOS-1. Due to the size of the project and the short working window, a team of Mixers, Runners and Applicators were utilised. Belzona 1111 was firstly used to fill in badly corroded areas. The poor substrate condition in some areas required a surface-tolerant solution, therefore, Belzona 1212 was used in these.
