BELZONA IMPROVES SAFETY WITH GRIP SYSTEM

Factory, Kirkop, Malta.

Factory main entrance steps.

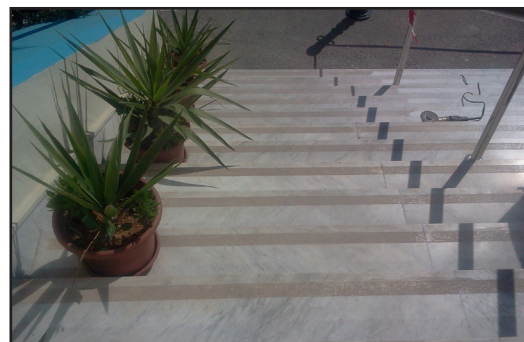
Marble stairs were very slippery, especially in wet conditions.

1. Abraded nosing resulted in a non-effective solution
2. Nosing ground by carbide discs
3. Area masked off
4. Completed application
