PINTLE PIN AND HOUSING REBUILT WITH BELZONA

Rudder pintle pin and housing on a large ship.

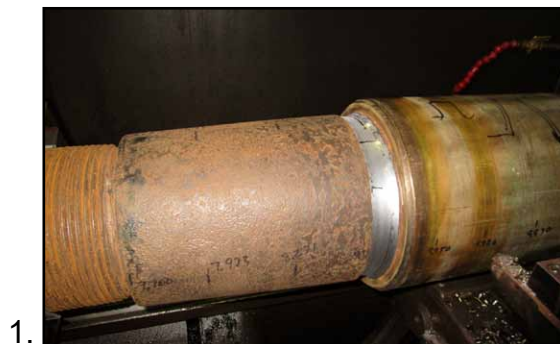
Seawater had corroded the pintle pin and housing enough so that the pin was a loose fit in the housing.

1. Pintle pin showing corrosion.
2. Pintle pin rebuilt and ready to form new housing.
3. Pintle housing showing corrosion before grit blasting.
4. Pintle housing rebuilt, ready for final assembly with Belzona 2111 sealing both ends.

The worst of the corrosion on the pin was undercut on a lathe and rebuilt with Belzona 1111. Next, the pintle housing was grit blasted and coated with Belzona 1111. The pin was coated with a release agent and lifted into the housing to form a perfect fit. The rebuilt housing was inspected and then reassembled using Belzona 2111 to seal the top and bottom of the pintle housing.
