BELZONA RESTORES AND PROTECTS GATE VALVE

Copper Mining Company, Bulgaria

Three large gate valves for water transport from the local dam to the production area.

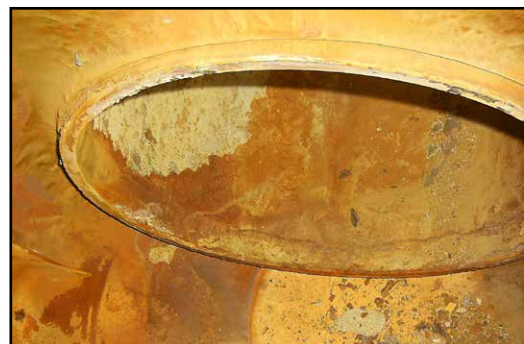
Strong corrosion and erosion on the inner surfaces of all 3 gate valves.

1. General view of the valve before repair
2. After blasting and flange masking
3. 1st coat of Belzona 1341 applied
4. Final view of the completed application

The application was carried out according to Belzona Know-How System Leaflet CEP-1 and CEP-3. The internal welds, pitting and damage were filled with Belzona 1311 then two coats of Belzona 1341 were applied.
