BELZONA RENEWS 40 METRE VERTICAL EXPANSION JOINT

Industrial unit, Malta

August 2014.

Failed expansion joint at industrial building.

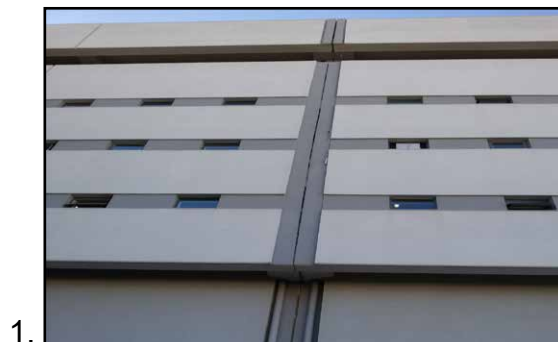
1. Existing joint material removed and cleaned.
2. Masking and conditioned.
3. Application of Belzona 2211
4. Completed Application

The application was carried out in accordance with Belzona Know-How System Leaflet WPA-3 and WPA-9. The existing joint material was removed and the edges were rebuilt with Belzona 4141. Belzona 2211 was applied to seal the joint. To further seal and encapsulate the joint, bridging tape was applied over the expansion joint prior to the application of the Belzona 3111 system. This also provided an aesthetically pleasing finish.
