40 PROCESS VESSELS LINED WITH BELZONA FOR NEW OIL & GAS PROJECT

Major Oil Company, Iraq

July 2016 - to March 2017

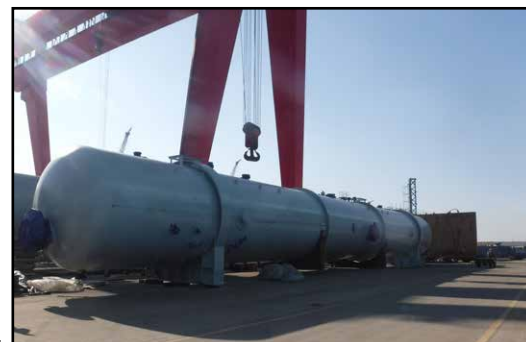
1. Overview of 120K desalter
2. Coating application
3. Belzona inspector is doing final inspection with client.
4. Application completed
