BELZONA PROTECTS RAIL CARRIAGE ROOFS

Railway operator, Portugal

Roof on railway carriage

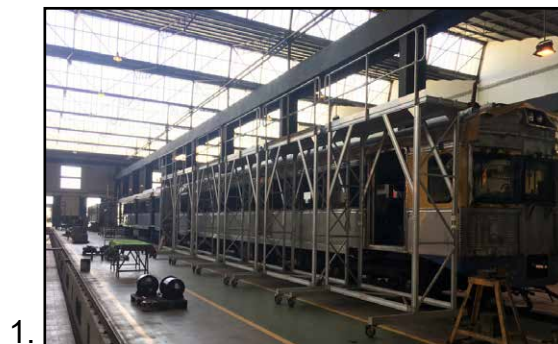
1. Railway carriage
2. Roof to protect
3. Belzona 3111 application
4. Application completed

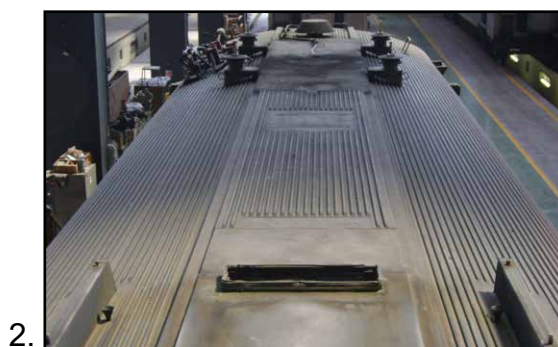
Water leaks on the roofs due to presence of small cracks and holes made to install specific furniture.
