EASY LINTEL REPAIR WITH BELZONA

Housing Association, Cleveland, UK

Residential Property

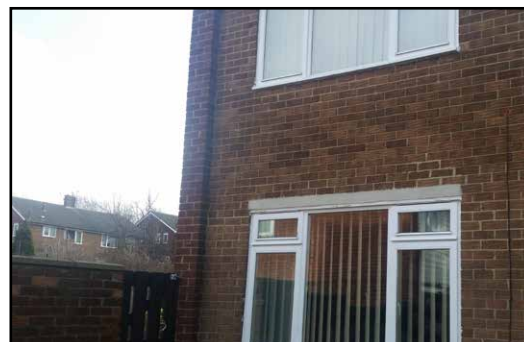
1. Overview (after repair)
2. Damaged Lintel
3. Damaged Lintel
4. Completed repair

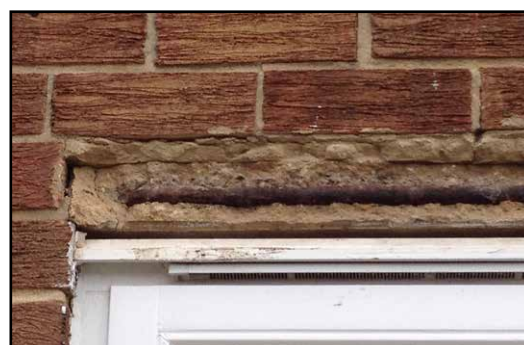
2.

The entire front face of the concrete "Boot" lintel had failed due to re-bar corrosion. The customer wanted a long-term solution without having the need to disturb the structure.

Belzona® 4141 (Magma-Build)

Belzona® 4911 (Magma TX Conditioner)

Application carried out in accordance with Belzona system leaflet WPA-4
