BELZONA STOPS LEAKS AT A PUBLIC HOUSING AUTHORITY

Housing Authority, New York, USA

Condensate overflow tanks

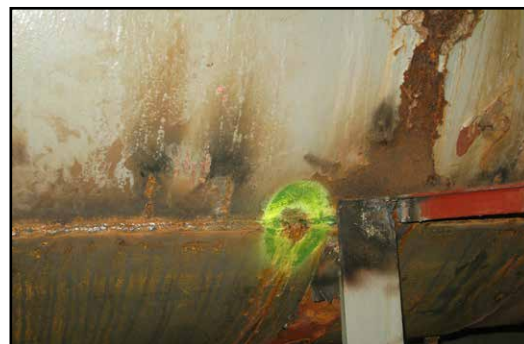
The condensate tank had moderate to severe corrosion in various spots with 11 existing leaks. This led to the room being regularly flooded.

1. The leaking tank
2. Application of Belzona materials
3. Removing the masking tape
4. The tank following after the completed application.
