## BELZONA PLATE BONDING ON SHIP'S DECK

Cape Town, South Africa

July 7, 2017

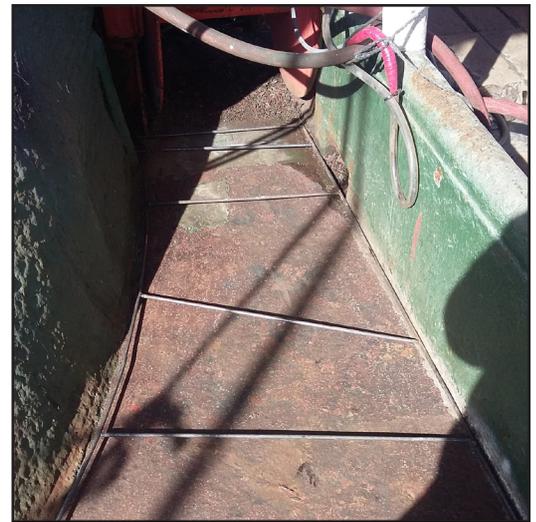
The rear section of the main deck of the ship was badly damaged by years of corrosion and wear and tear.

1. The deck before preparation.
2. Belzona technician checking ambient conditions.
3. Plates after initial bonding.
4. Completed application protected with Belzona 5811.
