PARKS AND RECREATION RESTROOM FLOOR COATED WITH BELZONA

Montana, USA

May 2017

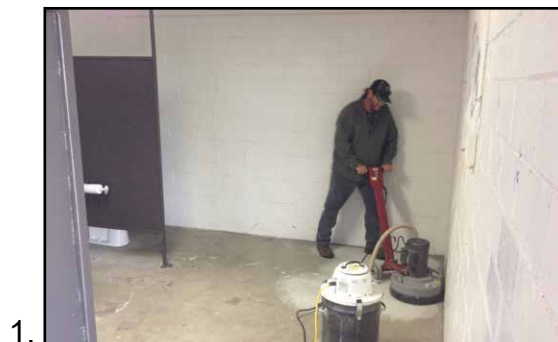
1. Performing floor grinding preparation.
2. Surface edge and floor grinding complete.
3. Belzona 5811 application complete.

The application was carried out in accordance with a modified version of Belzona System Leaflet FPA-3. The floor was ground with diamond grinders. Within the overcoat windows two full coats of Belzona 5811 were applied.
