## ELEVATOR PIT LEAK SEALED WITH BELZONA

Missouri, USA

December 2017

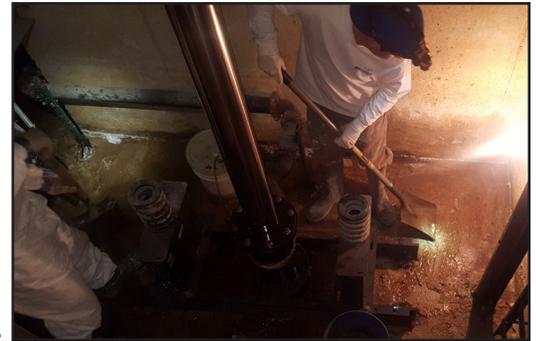
The concrete pit of an elevator shaft had begun to deteriorate and allow water to enter the pit, damage the substrate and corrode the supporting steel structures.

1. Original condition of the elevator shaft. Full of muck, mud, oil, and standing water.
2. Belzona 4131 used to create a permanent seal around the elevator drive shaft.
3. Belzona 4151 applied as a basecoat.
4. Belzona 5231 used as a topcoat.
