## BELZONA PROTECTS COOLING TOWER BASINS FOR A SUGAR REFINERY

**CUSTOMER**  
France

**APPLICATION DATE**  
July 2018

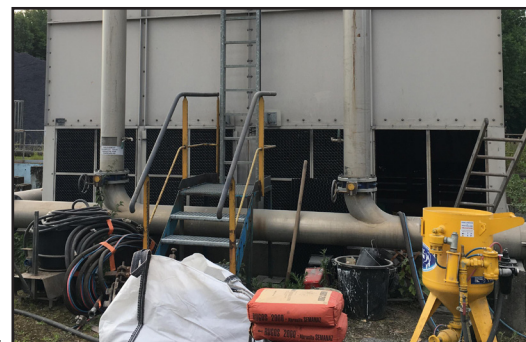
1. Outside view of the tank
2. Blasted pole inside the basin
3. Final application
4. Zoom on the final application
