RESIDENTIAL ROOF REPAIRED BY BELZONA

A residential building had an extension retrofitted, however water was penetrating between the house and the new roofing area.

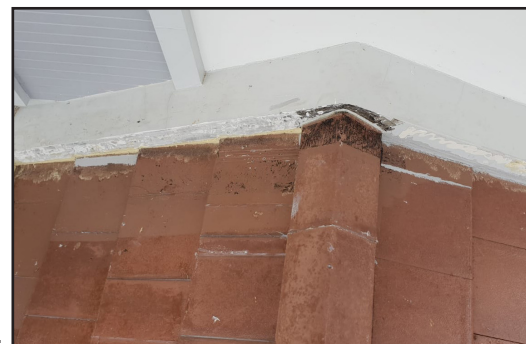
Rain water was pooling and penetrating under the roofing tiles. Several attempts were made with silicon and mastic materials to address the problem.

1. The roofing area
2. Rebuilding with Belzona 4141
3. Application of Belzona 3111
4. The completed application
