BELZONA PROTECTS WASHING POWDER HOPPERS

Hoppers supplying storage bins in the manufacture of washing powder

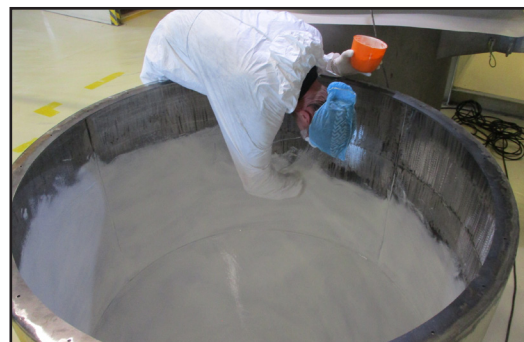
The citric acid content of the washing powder was causing erosion-corrosion to the supply hoppers

1. Application in progress, showing the unprotected substrate.
2. Closeup of the finished coating.
3. The equipment at hand.

The application was carried out in accordance with Belzona System Leaflet TCC-3. Belzona 1331 was applied by brush.
