## COOLING WATER OUTLET PROTECTED WITH BELZONA 1321

Sea water used as coolant in open cooling system in coal fired power station. Steel cooling water outlets below the condenser

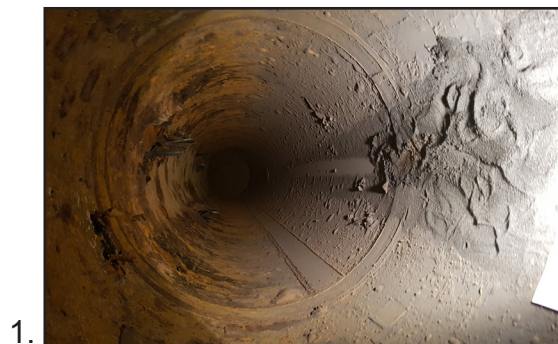
1. Rubber lining in outlet pipe
2. Condition of rubber lining
3. Blasting in progress
4. Finished Belzona 1321

The existing rubber lining had reached its end of life. The existing rubber was no longer providing the steel pipes with protection from erosion/corrosion. The rubber needed to be removed to allow for application of Belzona 1321.
