BELZONA REPAIRS DAMAGED DRUM FILTER TO KEEP WASTEWATER PLANT RUNNING

Wastewater treatment plant drum filter.

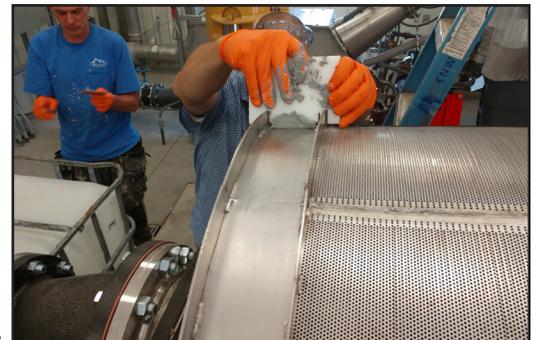
1. Belzona 1221 being applied first with a stiff bristled brush and then smoothed with a simple former.
2. Belzona 1221 applied.
3. Belzona 2121 in red applied.
4. Completed job with second coat of Belzona 2121 in black.

Substrate was cleaned and degreased and then given a surface profile with an MBX Bristle Blaster. The surface was then degreased again. Belzona 1221 Super E Metal was applied to the lowest points (dents) to build them back up. A custom former was used to help ensure concentricity. Belzona 2911 was applied to condition the surface and allowed to cure. Then a coat of red Belzona 2121 Hi-Coat Elastomer was applied followed by a second coat of Belzona 2121 in black.
