## BELZONA REPAIRS PRIVATE RESIDENCE OUTDOOR POOL SKIMMERS

Corrosion and erosion of steel backing plate around pool skimmers.

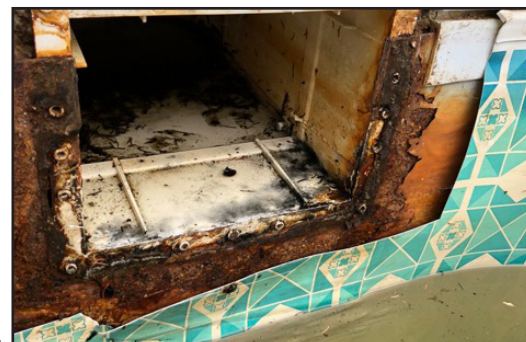
The customer was looking to do routine maintenance on the vinyl pool liner. When the liner was peeled back, there was heavy corrosion and metal loss on the steel backing plate around the skimmer housing areas. The customer wanted a Belzona solution to restore/repair the metal loss and prevent water from leaking behind the backing plate and skimmer housings.

1. Before photo showing extent of corrosion around skimmer housing.
2. Repair area bristle blasted and cleaned.
3. Belzona 1161 used to repair metal loss around skimmer housing
4. Finished application with two coats of Belzona 3121.
