## BELZONA PROTECTS A ROOF ABOVE TRANSFORMERS

A roof made of steel and bitumen needed to be repaired and protected.

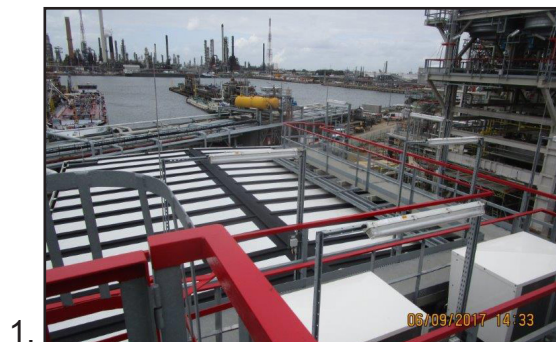
The roof had been protected with a bitumen coating, however, this was found to be unsatisfactory by the customer. As well as this, thanks to the building not being built to specifications, there were an estimated 160 perforations across the whole of the roof. This needed to be repaired and protected given the fact that the roof protects transformers and leaks could be very dangerous.

1. Overview of the roof before the application
2. A close-up view of the roof before application
3. Final application

The application began with the steel roof being cleaned with water and powder cleaner to remove all surface contaminants. According to a modified version of Belzona Know-How System Leaflet RPA-1, the surface was then manually roughened. A coat of Belzona 3921 Conditioner was then applied followed by a two-coat system of Belzona 3111 with a reinforcement sheet used in the first coat.
