## BELZONA REPAIRS AND PROTECTS AN OLD VACUUM PUMP TRUCK

Old large vacuum pump truck for a private utility company.

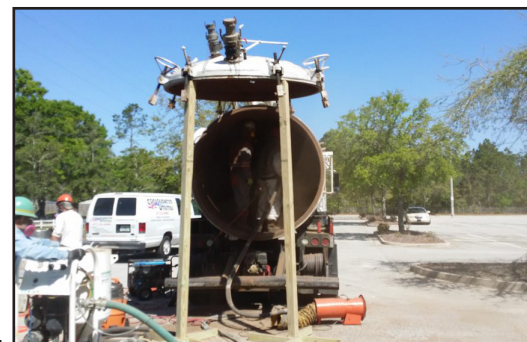
1. Surface preparation by blasting.
2. Blasting of the inside of the vacuum truck.
3. Completed internal lining with Belzona 5821

Application was carried out with a modified Know-How System Leaflet TCC-5. Blast cleaned the steel to achieve the American Standard near white finish SSPC-10 with an angular profile of 3 mils. Cleaned and scrubbed with a salt cleaning solution to remove salt contaminants and tested for the minimum level of chlorides. Re-blasted the substrate to remove surface flash rust before application. Applied Belzona 1212 combined with a reinforcement sheet to cover pinholes, and applied Belzona 5821 as a protective coating.

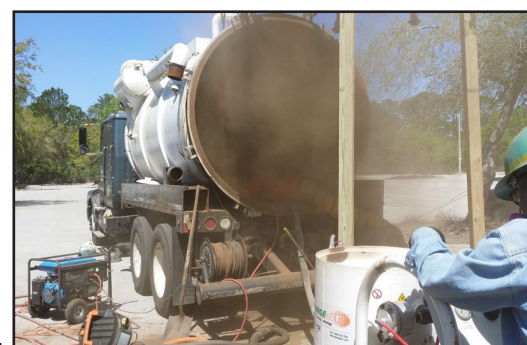
Main tank of the vacuum pump truck had no previous protective coating. The steel substrate inside had exhibited small through pin holes and was severely corroded.
