SEALING A LEAKING AIR HANDLER WITH BELZONA

Office Building, Kansas, USA

September 2018

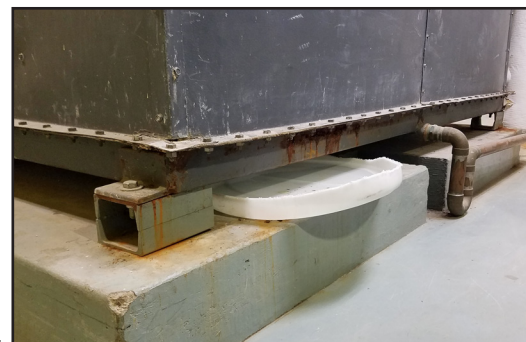
Several air handlers exactly like this one were leaking and showing general signs of wear and tear. The configuration of these air handlers, however would not allow an effective interior lining to be applied due to the confined space and limited access.

1. Damaged area of one of the air handlers.
2. Application of Belzona 1161 embedded with Belzona 9341.
3. Area of application masked off and ready for application of product.
4. Application of Belzona 3412 finished.

The metal was cleaned and prepped with hand tools, so that any holes could be addressed with Belzona 1161 repair metal and mesh, and then coated over with Belzona 3412. The entire flange and seam was coated to ensure that any out of site leaks or penetrations would be sealed. The applicaiton was carried out in accordance with a modified version of Belzona Know-How System Leaflet GSS-11. Rather than making an open flange seal we decided to simply use the system without the release agent and bond the entire area to the substrate. This was done because there was no need to re-access the repaired area after the application was complete.
