A BELZONA "SMOOTH" OPERATION FOR A FAILING EXPANSION JOINT AT A MEDICAL FACILITY

Medical Center, Kansas, USA

September 2018

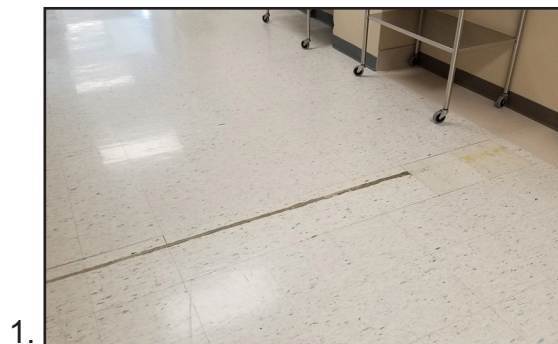
1. Existing damaged expansion joint.
2. Removal of failing sealant and spalled concrete/tiles.
3. Pouring Belzona 2221.
4. Application done, expansion joint ready for traffic.

The application was carried out in accordance with Belzona Know-How System Leaflet FPA-6. The expansion joint is located next to the operating room, so hepavac double sealed containment was built before work began. After containment was up the old tile and failing area below were removed and Belzona 2221 was poured into place to create a sealed and flexible new joint. The containment was built the day before work started, the removal and application only took one day. The containment was removed the following morning and the hospital was ready for surgeries to begin in that Operating Room.
