PRIMARY CRUSHER BASE REPAIRED WITH BELZONA 4111 AND BELZONA 4151

Copper Mine, Brazil

Base of a primary crusher at a mine.

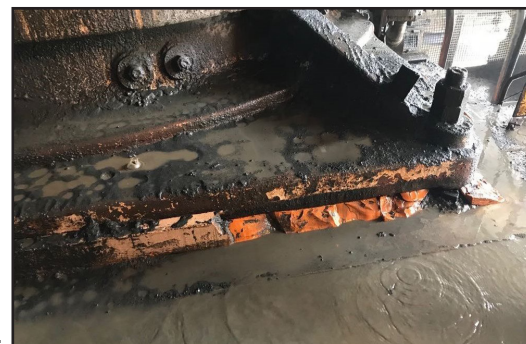
Excessive vibration of the crusher caused the concrete base to crack which could potentially compromise the functionality of the machinery.

1. Damaged base of the crusher.
2. The perimeter of the base rebuilt with a regular mix of Belzona 4111.
3. A fluid mixture of Belzona 4111 and Belzona 4151 resin used to fill in the void and have it self-level in the base.
4. Foundation of primary crusher repaired with Belzona 4111 and Belzona 4151.
