BELZONA DELIVERS CRITICAL SOLUTION USING ROPE ACCESS

Water Taxi Service, Trinidad and Tobago

An interisland ferry that transports passengers between islands.

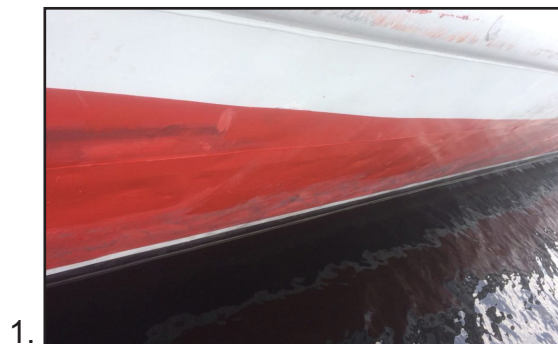
The ferry had sustained a series of dents on its starboard side above the water line. One of the dents was perforated. The boat had recently come out of dry dock in preparation for certification and it was virtually impossible to send it back to dry dock given the cost and the tight timeline to commission it.

1. Damaged areas on the starboard side of the ferry.
2. Perforated dent area.
3. A technician at work on a rope access.
4. Complete application.

The solution involved Rope Access to apply Belzona 1111 and Belzona 9341 to rebuild the dents and seal the perforation. The application was carried out in accordance with modified versions of Belzona Know-How System Leaflets SOS -1 and SOS -2. We accessed the repair area via a 4-man rope access team. Surface preparation was performed using an MBX. The customer had their Project Manager on site and the service provider had a NACE & 2 Inspector.
