OXYGENATION TANK REBUILT AND PROTECTED FOR YEARS TO COME

Oxygenation tank at a wastewater plant. Customer required protection of this tank for years to come. Time was of the essence because rainy season was very close.

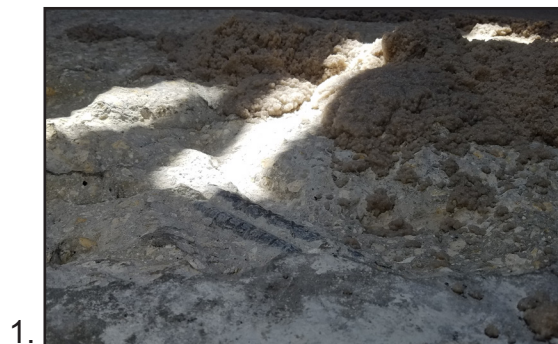
The tank had not had protection for years, and as a result the concrete walls and floors were in a bad shape. Some sections showed erosion as deep as 3'. Large mixer blades had caused a severe erosion the tanks' structure. The time was of the essence because of the rainy season.

1. Damaged Concrete.
2. Concrete rebuilt with Belzona 4124.
3. Concrete coated with Belzona 5811.
4. Belzona Alumina Tiles System installed: Belzona 5811 as a base coat, Belzona 9811 and Belzona 1812 (as a grouting compound).
