## BELZONA 1212 STOPS A LIVE LEAK IN A COOLING TOWER PAN

Manufacturing Facility, Tennessee, USA

October 2016

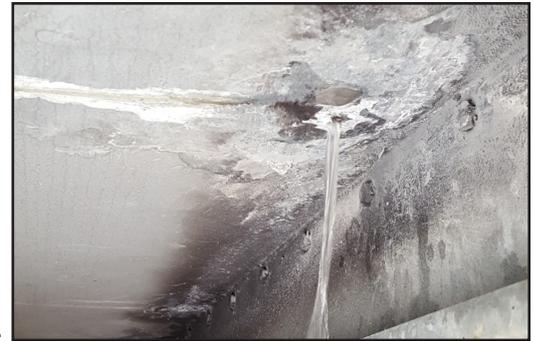
Several live leaks in a cooling tower pan were leaking water at a rate of several gallons per hour. The Customer needed a way to stop the leaks without shutting the tower down and interrupting their manufacturing process.

1. Leak with evidence of previous repair attempts visible.
2. Stemming the leak with Belzona 9611.
3. Plate pressed into place with Belzona 1212 and a hydraulic jack
4. Cold bonded repair complete with a final bolt in place.

The application was carried out in accordance with a modified version of Belzona Know-How System Leaflet TCC-1. A plate was had been fabricated with a hole in the middle to allow water to run out and a 1/2" nut was inserted into the plate using Belzona 1212. The repair area was prepared using hand tools and a mechanical grinder and the leak was partially stemmed using Belzona 9611. The prepared area and the plate were then wet out with enough Belzona 1212 to create a good bond and the plate was pressed into place and held using a hydraulic jack. Water was allowed to run through the hole in the nut while the plate cured in place for approximately 60 minutes. The jack and support bar were then removed. A small amount of Belzona 1212 was added to the threads of a 1/2" bolt and it was screwed into place to stop the leak and finalize the repair.
