## BELZONA PROVIDES LONG-TERM PROTECTION TO A TURBINE'S INLET SCROLL AND BELLMOUTH

The inlet scroll and bellmouth of a gas-fed turbine was previously coated with an inadequate coating.

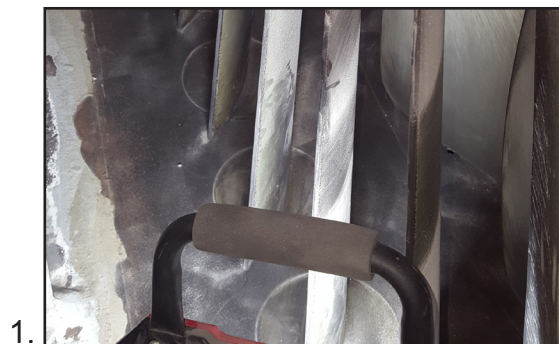
The failing coating provided no protection to the substrate against the environment and could flake off into the turbine. This could potentially lead to catastrophic damage including total shutdown and repairs to the turbine blades in excess of \$200,000.

1. Failing coating on the substrate.
2. Blasted substrate.
3. Coated substrate with Belzona 5892.
