BELZONA SUPERWRAP II SUCCESSFULLY TACKLES A LIVE LEAK REPAIR

Fiberglass 36" pipe of a cooling tower.

The pipe burst after an outage causing the plant to shutdown.

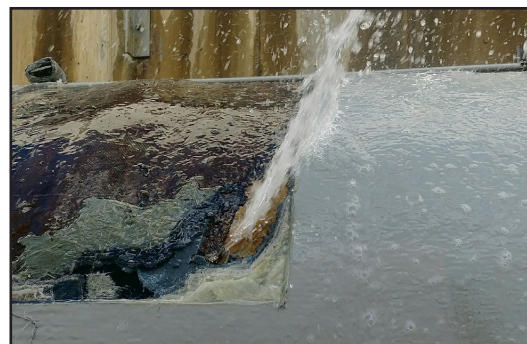
1. Showing damage.
2. Surface preparation.
3. Plate bonding with Belzona 1212.
4. Superwrap II System installed.
