BELZONA PLATE BONDING APPLICATION HELPS A MILITARY VESSEL DEPLOY ON SCHEDULE

APPLICATION SITUATION
Aluminum hulled pontoon ship

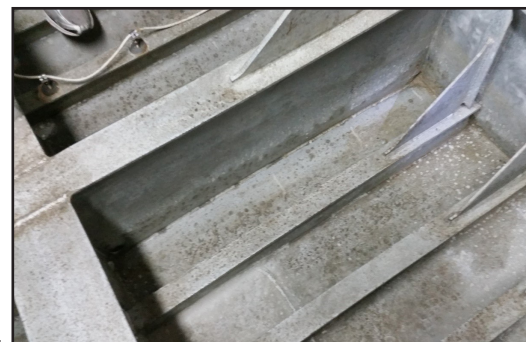
Water was leaking into two compartments, located against the aluminum hull of the ship (approximately 400 Square Feet of total repair area). The shell of the hull and stiffeners in the spaces were corroding from salt water, which was collecting in lower reaches of the space. The corrosion had progressed to the point that the water was leaking and traveling into adjacent hull locations. Stitch welding of the vertical stiffeners to the shell was hiding much of the corrosion.

1. Showing damage caused by corrosion.
2. 1st coat of Belzona 1321 applied.
3. Doubler plates embedded with Belzona 1111.
4. Complete application.
