## GRAND STAIRCASE OF A FUTURE HOME OF A HISTORIC MUSEUM RESTORED WITH BELZONA

Pre 1920 cast-iron grand staircase.

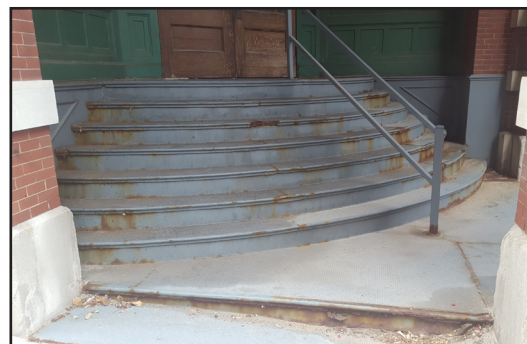
The original build grand staircase made from pre-1920 cast-iron had severe rust and multiple failures. It was a tremendous eyesore and in some areas impassible.

1. General view of the staircase showing damage.
2. Stair nosings rebuilt with Belzona 1211 and steel rods.
3. Two coats of Belzona 5231 loaded with Surefoot Aggregate on walking treads applied.
4. Belzona 5233 applied as a top coat for UV-stability.
