## BELZONA 1111 RETURNS PROPULSION UNIT ON A TOWBOAT BACK TO SERVICE

Towboat, Washington, USA

A towboat propulsion unit.

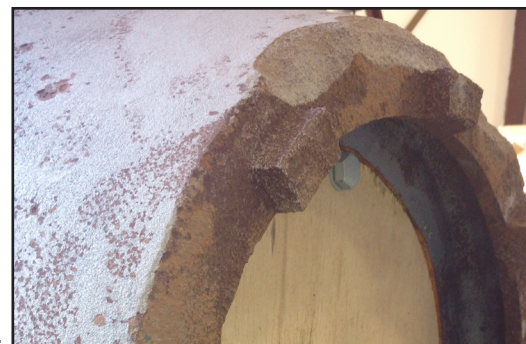
Erosion of the steel on this propulsion unit was getting fairly deep in some parts.

1. Original condition of the propulsion unit showing the corrosion and loss of material.
2. Application of Belzona 1111 complete.
3. Belzona 1111 sanded down to the correct profile, and grit blasted for the application of Belzona 1331.
4. Applying Belzona 1331.

The application was carried out with modified versions of Belzona Know-How System Leaflets SOS-1 and SOS-2. The surface preparation and Belzona 1111 application to rebuild erosion was completed in July 2017. In September 2017 the application of Belzona 1331 took place. A 3-5 mil profile was achieved using alumina oxide. The surface was then washed down with a cleaner/degreaser and Belzona 1331 was applied at a thickness of 10 mils by brush. The following day the second 10 mil coat of Belzona 1331 in grey and was allowed to cure. This gave an overall system thickness of 20 mils. The Customer left a 1.5" section unfinished at the end where the two units would be attached upon installation in October 2017. After it was completely installed they grit blasted the un-coated joint and applied two coats of Belzona 1331 on the 3" un-coated section and 2" over the existing Belzona 1331 to leave a solid seamless finish. The entire application was performed by two employees, except for the blasting.
