BELZONA SAVES SILO LID

The customer manufactures concrete beams, blocks and other structures at their large site in Bedfordshire. The silo is a vital part of their plant as it is used to bulk store cement powder. Any moisture ingress will ruin the stored materials.

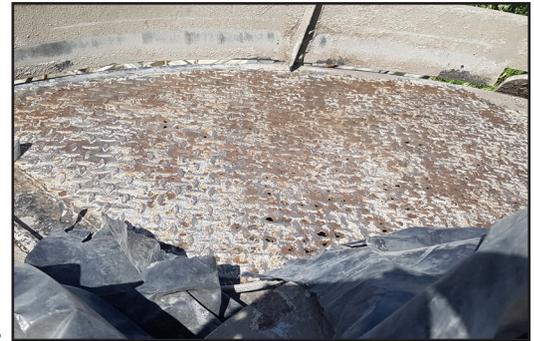
The customer had noticed problems with their cement storage silo and after inspecting found that the lid was severely corroded and was letting in rainwater. The silo is 11 metres high, to replace the lid would be logistically very difficult and incredibly expensive.

1. The silo lid at the start of the repairs
2. A closer look at the damage
3. The lid repaired with B1111 plate bonding techniques
4. The finished lid
